## CHANGES IN HISTORIC SITE FUNCTION:

### THE JOHNSON-TAYLOR ADOBE

Susan M. Hector  
San Diego County  
Department of Parks and Recreation  
5201 Ruffin Road, Suite P  
San Diego, CA 92123

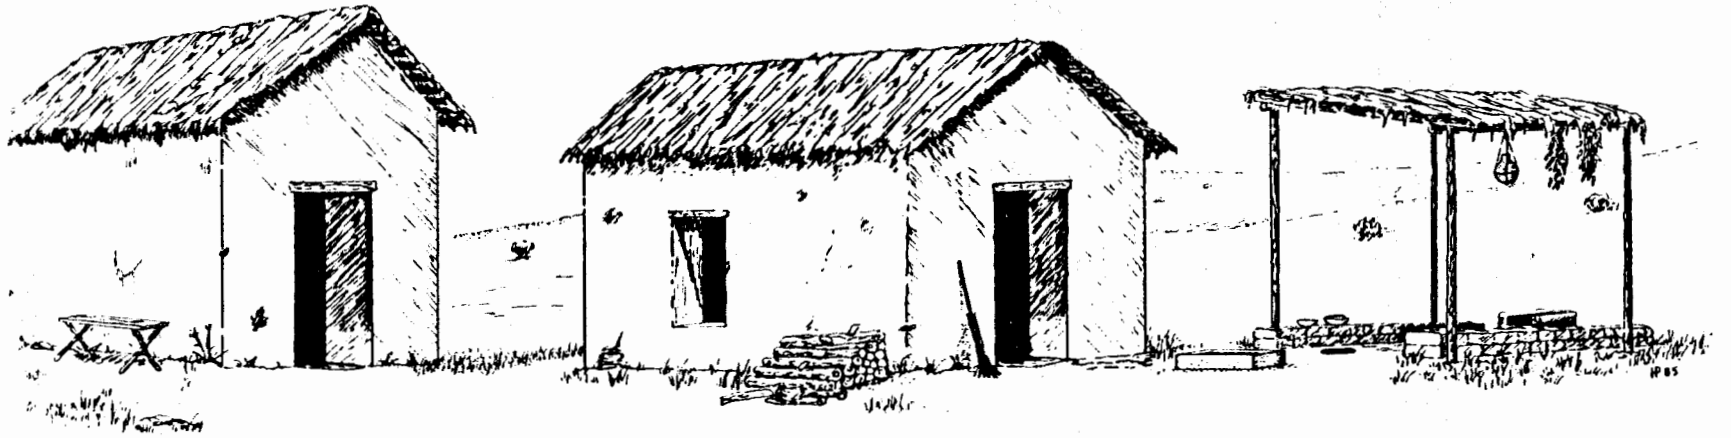
Figure 1. Artist's reconstruction of Mexican Period adobe settlement.

To sum up the findings about the changes and functions of Wings A and B, a series of figures is presented. Figure 1 shows the adobe as it was before Johnson began any additions. There is a Patio Activity Area on both sides of the adobe room. This shows where the large pot was found, and where the concrete and cobble trough is located. The low wall made from adobe blocks is also shown as the eastern end of the activity area. This eastern end was probably the exterior kitchen. This period appears to represent use by a small Mexican family settlement, since artifacts and features are most typical of that type of household.

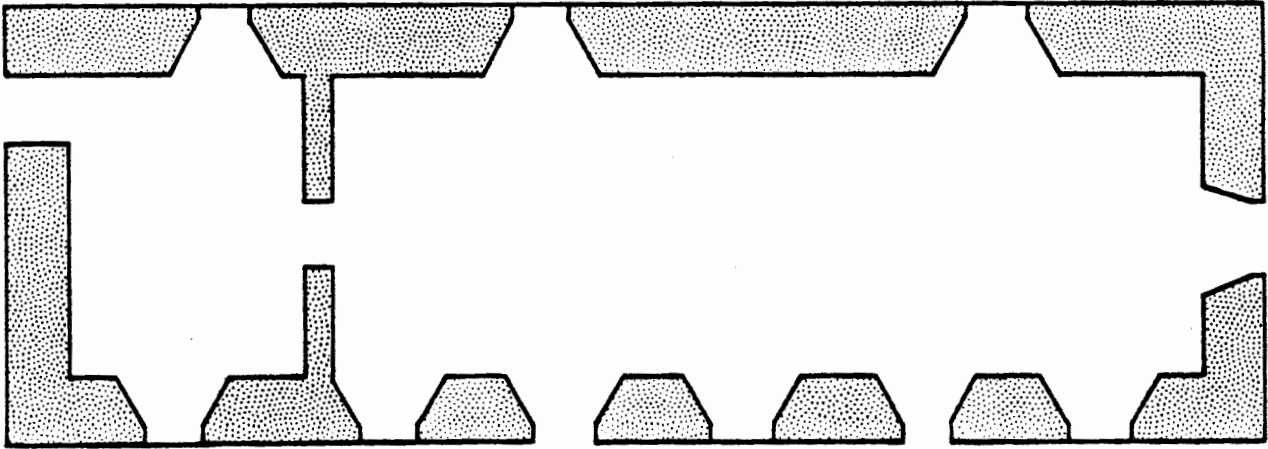
Figure 2. Johnson Period, 1860-1880.

Figure 2 shows changes made by Johnson in 1862, when he arrived at the ranch. The room was enlarged, and another small adobe room was added to the western end of the main room. The scatter from this period forms another concentric ring around Wing A. This great intensification of use in the area implies a large ranching community in development. Artifacts and features from this period indicate a remaining orientation towards the Mexican style of ranch development.

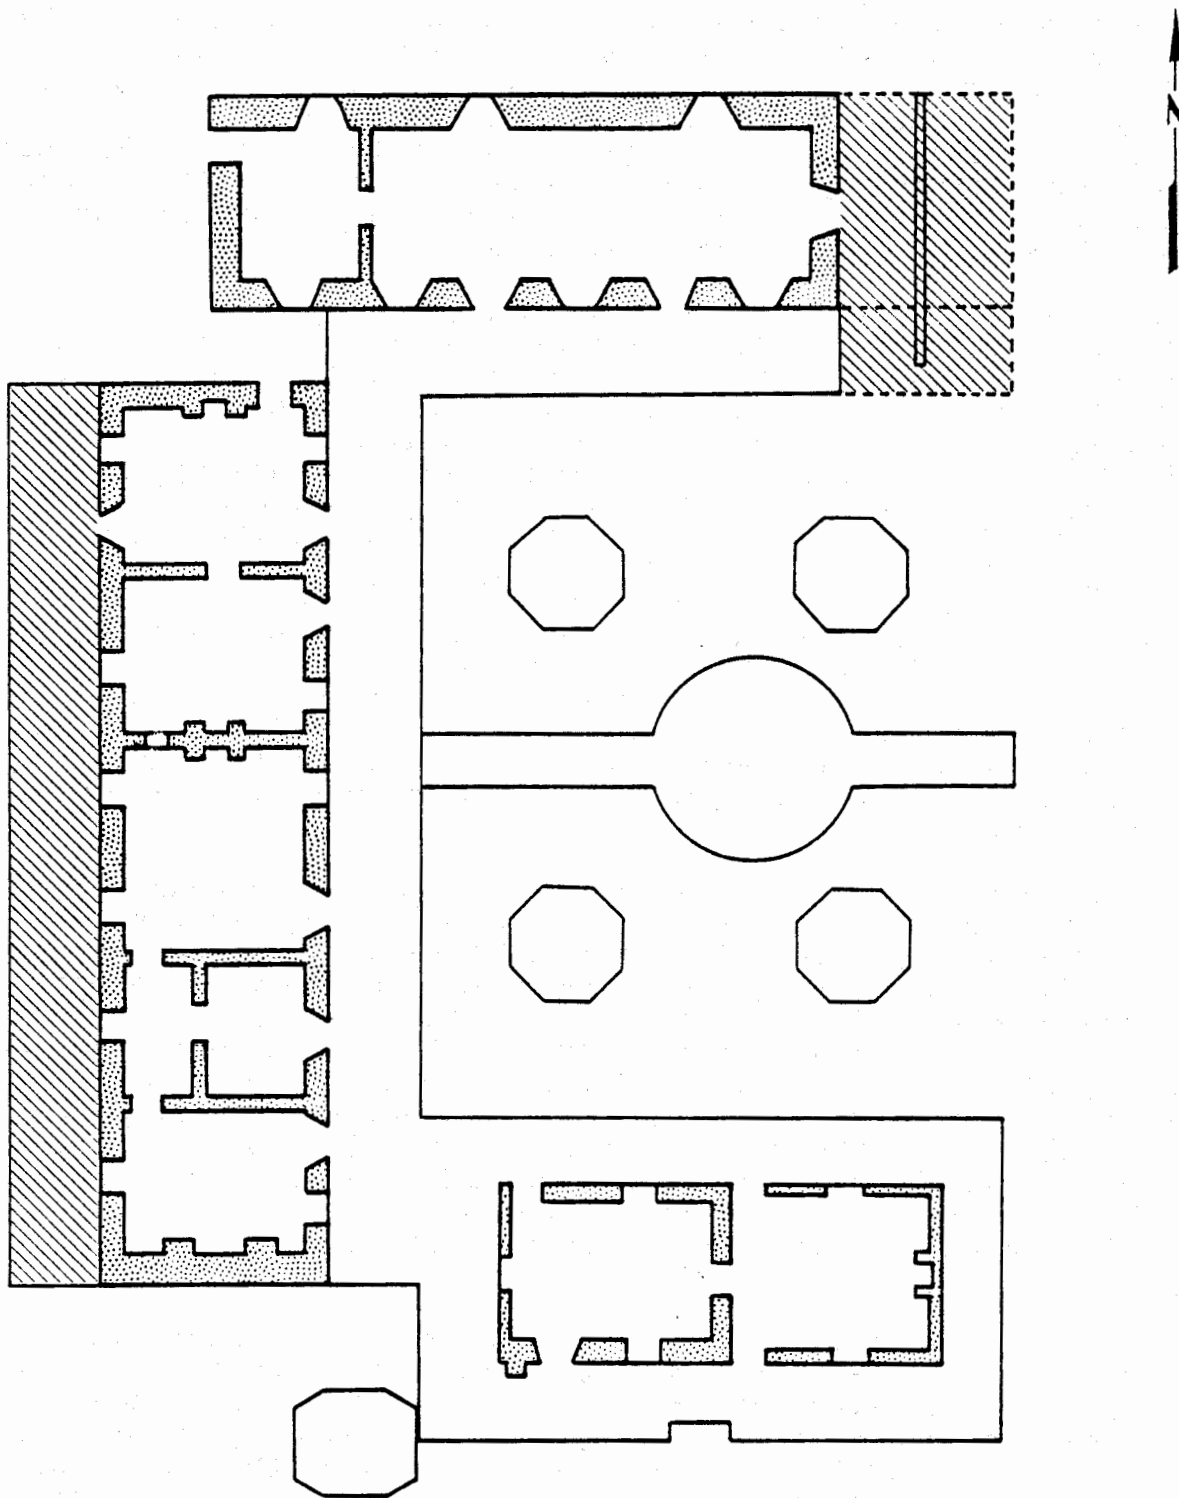
Figure 3. Construction between 1865-1913.

The next phase, shown as Figure 3, was a major building period at the ranch. From circa 1865 to the fire in 1913, Wings B and C were added. Interestingly, Wing B is made in an American style, while Johnson's additions to Wing A were continued in the Mexican style. Wing B is an adobe set on a mortared stone foundation; it is on a slope that required a foundation of up to five feet in height at the southern end. In contrast, Wing A is set flat on the ground, on a cobble foundation. As part of a later phase of study, project archaeologists collected and processed adobe blocks from all proposed periods at the ranch to identify temper and any floral materials that might indicate differences in time or place of construction. Three adobe block

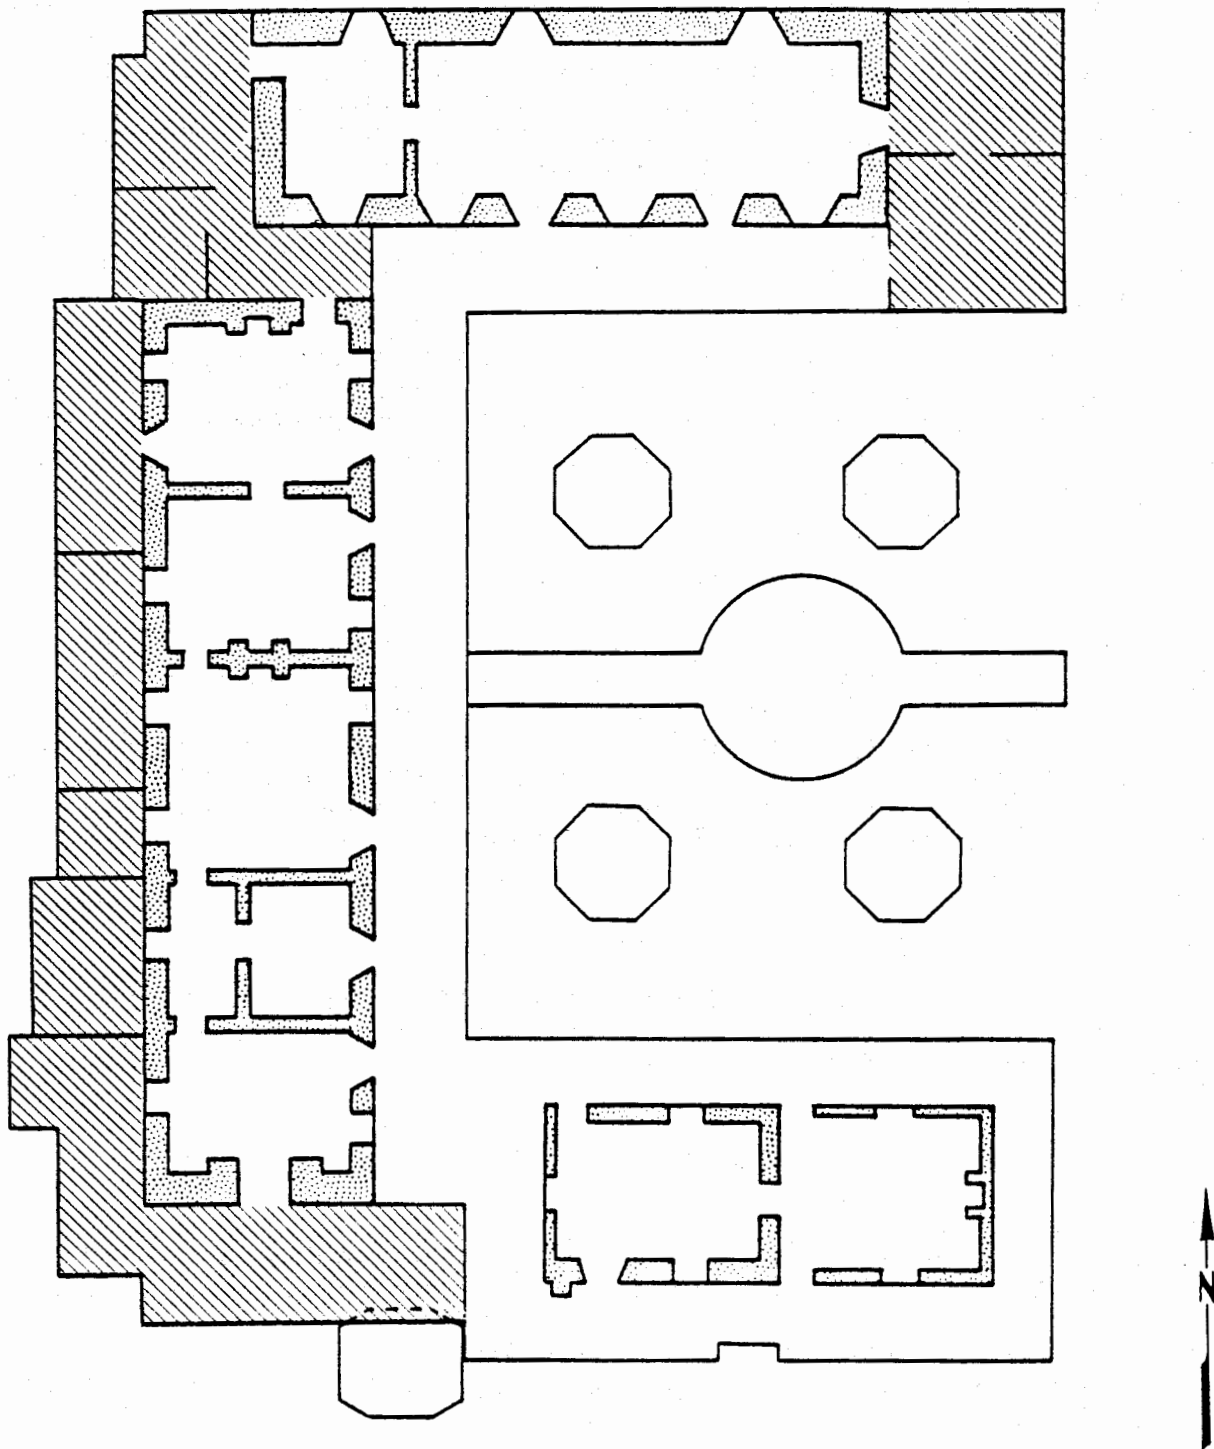
Figure 4. Wooden additions made after 1940.

After the 1913 fire, wooden additions were made on both ends of Wing A. No charred wood has been found in these additions to indicate that wooden structures were present in those areas before the fire. After 1940 (Figure 4), other wooden additions along the western and southern ends of Wing B were built; these have been demolished in preparation for the reconstruction. The post-fire period marked a return in function to a multi-activity ranch settlement.
