## GOVERNOR PICO'S "LITTLE RANCH" HOUSE REVEALS HER SECRETS

HERB DALLAS, JR.

*In the mid 1800s, the last Governor of Mexican California built his ranch house in Whittier. This large, 28-room adobe has survived floods, earthquakes, numerous owners, and the death of its original owner. DPR is undertaking a new restoration of the adobe and a reconstruction of the cultural landscape. The plan is to restore the building to its prime in the 1880s (Figure 1). The story of the adobe mirrors the life of its owner, the famed Don Pio Pico. It is a classic rags to riches and back to rags story. The man born into the mission system of Spanish California rose to be a Governor. The only surviving structure from this period in the area, this adobe is now revealing her secrets to archeologists and historians during the restoration. This paper will outline that restoration and the fascinating story that goes with it.*

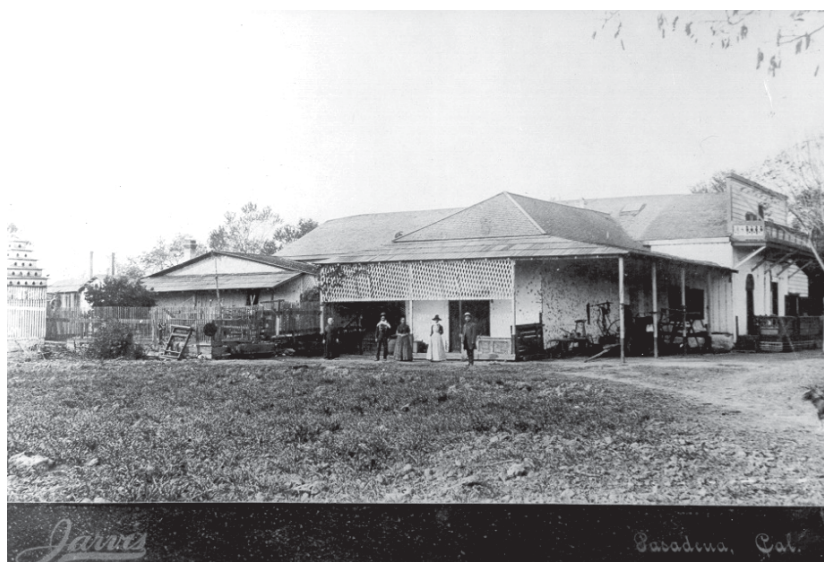
*Figure 1: View of the Pio Pico ranch house in the mid-1880s. Note the dovecote on the left, smokehouse in background, and early façade.*

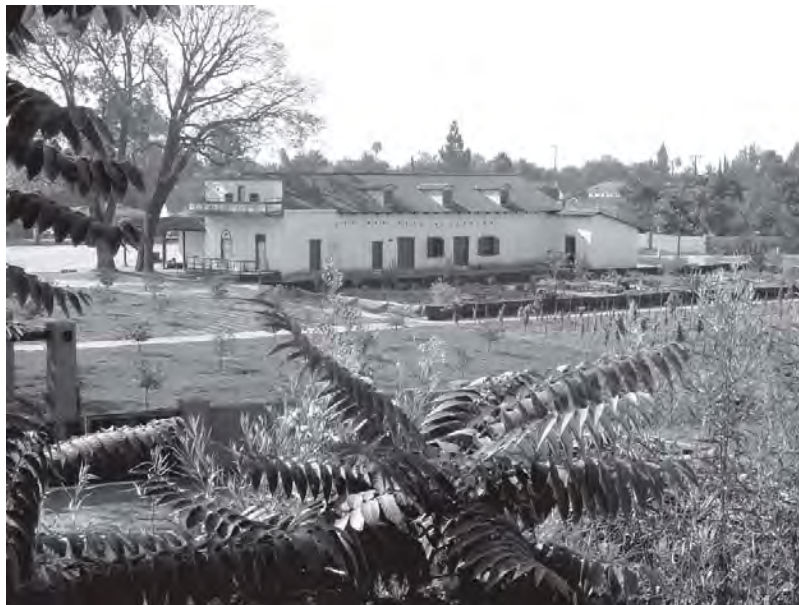
*Figure 3: West view of the Pio Pico adobe prior to restoration and landscape reconstruction. Note one of several non-contributing structures in the foreground.*

The restoration of the Pio Pico adobe was very ambitious (Figure 3). First, seismic retrofitting occurred. Damages to the lower blocks were repaired. A new roof was installed. A new A-frame was erected over

the flat roof above rooms 1, 2, and 3. This necessitated a false floor in the attic in order to preserve the structural integrity of the rooms. Rooms 4, 5, 18, 19, and 20, and a second-story balcony, were reconstructed. New porch awnings were installed. Floors were restored, refinished, and replaced. The adobe was re-plastered. Old cement and other incompatible mortar were removed. A new electrical system was installed. Historic door hardware was restored and reinstalled. Modern compatible Baldwin dead-bolt locks were also added for security. Several of the doors and windows that had been changed in earlier restoration efforts were restored back to their original function or status during the period of interpretation. The function of the building changed from a static house museum to updated exhibits and interactive panels. Historic wallpaper was reconstructed and installed in the *sala* (Room 7) and in Room 14. A new state-of-the-art audio/video sound system was installed in Room 2. Room 11 was converted into an archeology interpretive room after it had been determined that it was not the remains of the kitchen (DPR 1990; Dallas et al. 2003). Also many historic landscape features were reconstructed for the reconstruction of the cultural landscape. A few of the most notable features are the orange orchard around the adobe, the gardens to the west of the adobe, and a dove cote. Some of the difficulties of reconstructing a cultural landscape were outlined in an article for *Landscape Architecture Magazine* (Sorvig 2005).

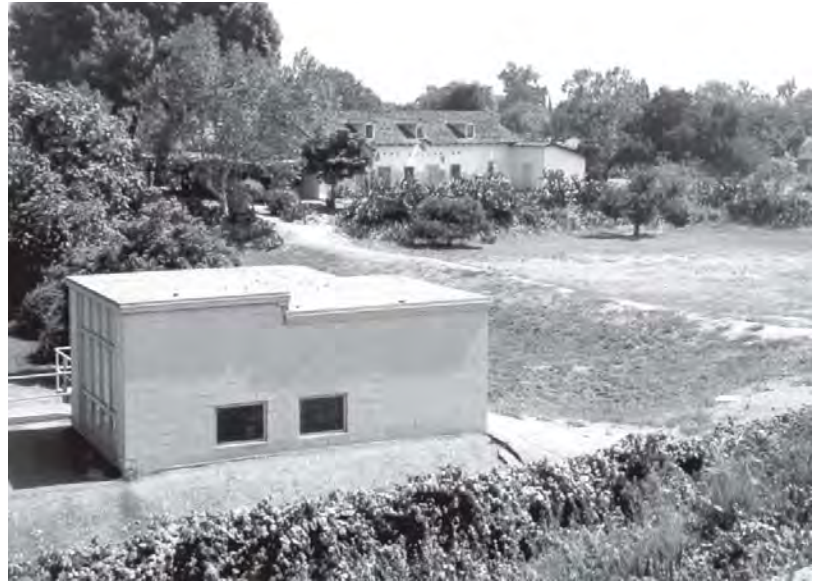
*Figure 4: Pio Pico adobe and landscape after restoration and reconstruction. Note that the front rooms have been reconstructed, second floor balcony, along with the front wooden façade as important character defining features of the building.*

Archeology also has added to the mystery of the adobe by finding things that are difficult to explain. For example, a wall was found upstairs that had graffiti scratched in it with the dates 1850 and 1853, yet the upper story supposedly was not built until 1879. These investigations also indicated that the adobe might have been enlarged earlier than was previously thought, matching the early description of a 20-room adobe. The mystery wall was found in the middle of room 11, dividing that room into two rooms. Was this room part of an earlier adobe? No trace was found of a mystery building that is shown next to the adobe in an early sketch. The final product is certainly a compromise, but a likely interpretation of an American rancho and adobe in the 1880s with strong Mexican influences (Figure 4). The public can now visit the restored adobe and learn more about the man, the myths, and the adobe.
